Trip Report 2002 Annual Inspection of the Parkersburg, West Virginia, Nuclear Waste Policy Act Section 151(c) Disposal Site

Summary

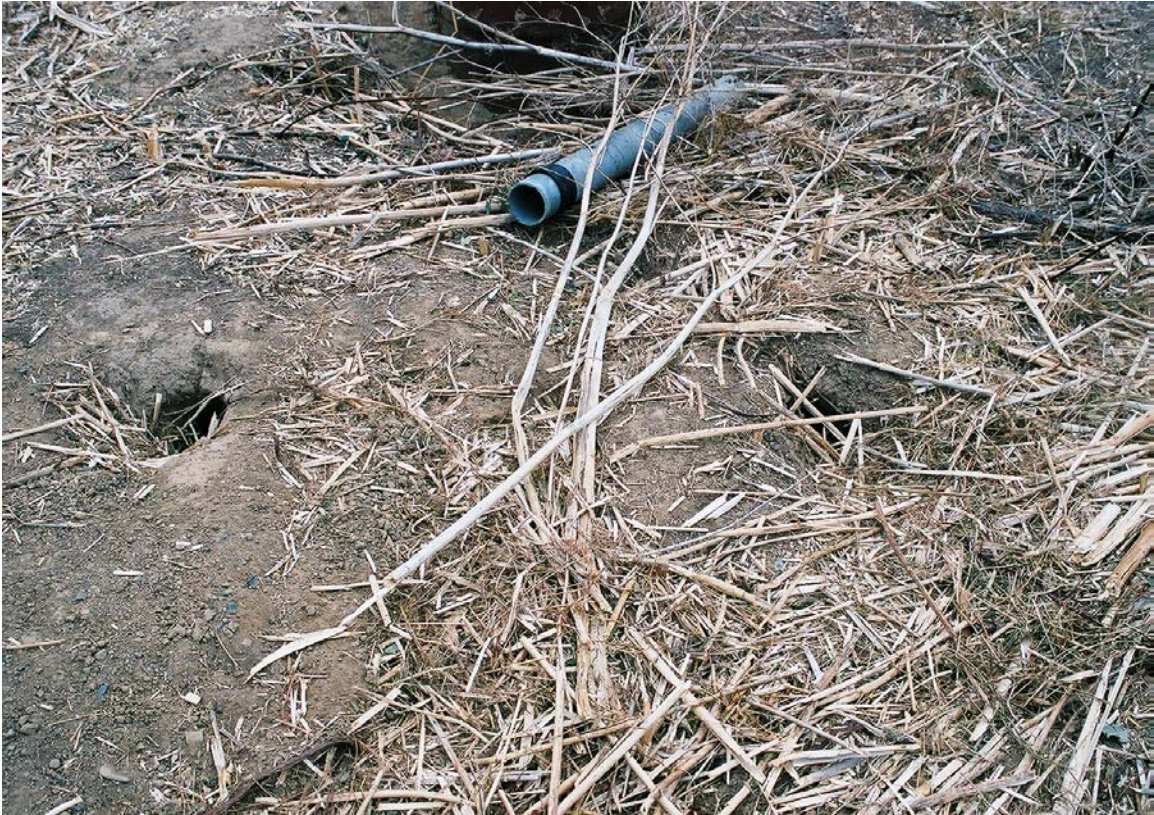
Inspectors noted burrowing near monitor well MW-1 (PL-1) and on the northwest portion of the site (PL-2). The burrowing brought soil to the surface that had the same characteristics of surface soil and was probably from the topsoil layer.

PKB 9/2002. PL-1. Burrowing near Monitor Well 1.

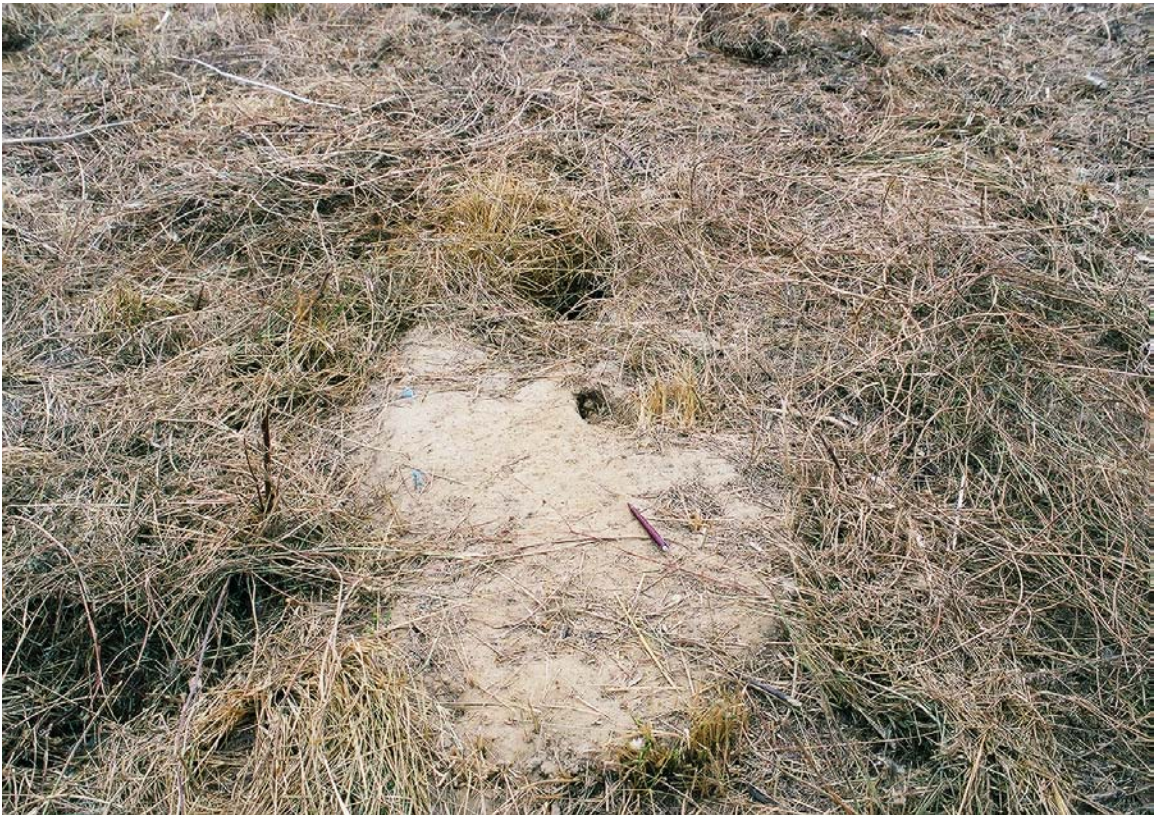
PKB 9/2002. PL-2. Burrowing on the northwest portion of the cell cover.

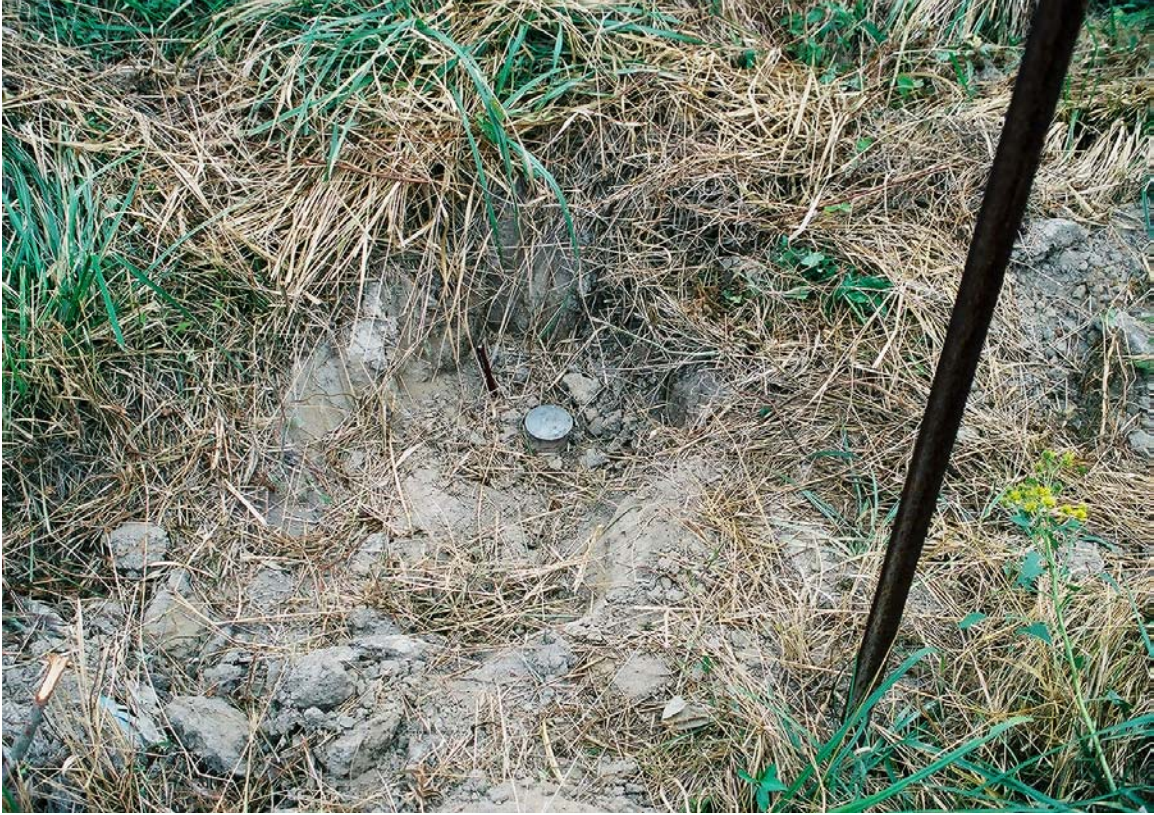
Inspectors could not find boundary monument BM-4 during the 2000 or 2001 site inspections. This monument is located in the bottom of a drainage ditch that parallels the northern property boundary. A local surveyor was retained to locate the monument, replace if missing, and install a reference monument away from the drainage invert. The surveyor found BM-4 covered by more than 4 inches of sediment (PL-3). All other boundary monuments were located and were in excellent condition.

4. Boundary monument BM-4 was found beneath sediment (page 3).

PKB 9/2002. PL-3. Boundary Monument BM-4.

Recommendation: A ground-level reference monument should be installed beyond the drainage invert.
